Metallized Film Capacitors Keep Pace With High-Voltage IGBT Modules

A single, self-protected, metallized polypropylene capacitor can operate at 3.3kVdc continuously and have an extended life of 100,000 hours or greater.

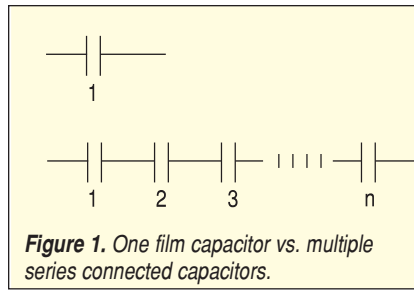
Figure 1. One film capacitor vs. multiple series connected capacitors.

- 1) The energy density increase of film capacitors has greatly reduced their size.
- 2) The reduction in film capacitor size has greatly reduced their cost.
- 3) The newer semiconductors now allow fewer series voltage levels in some applications. In these applications a single film capacitor replaces several series connected aluminum electrolytics (*Figure 1*).
- 4) A single film capacitor with a ripple current rating of 300 to 600A can replace 10 to 30 of the series wired groups in parallel (*Figure 2*).

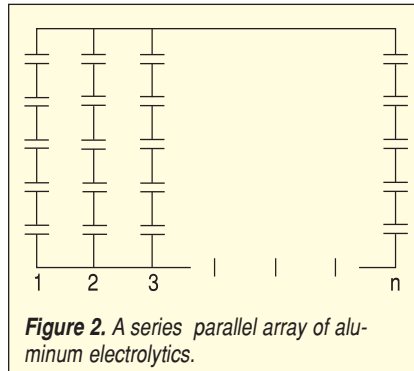
Figure 2. A series parallel array of aluminum electrolytics.

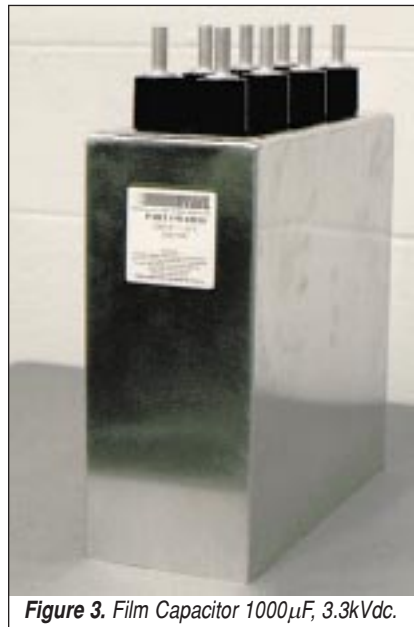
Figure 3. Film Capacitor 1000 μ F, 3.3kVdc.

The new type WA film capacitor is a selfprotected metallized polypropylene type in a welded aluminum case, which allows operation in magnetic fields generated by higher frequency operation. Often, stainless steel is substituted and serves a similar purpose. Terminal arrangements are made on the top of the capacitor to allow the parallel connection of several internal capacitor elements and a reduction in the series inductance. *Figure 3* shows a 1000 μ F, 3.3kVdc capacitor with eight terminals. This capacitor has a base of 34.3 cm x 15.0 cm and is 38 cm high. *Figure 4* illustrates the capacitor's configuration with four individual capacitors.

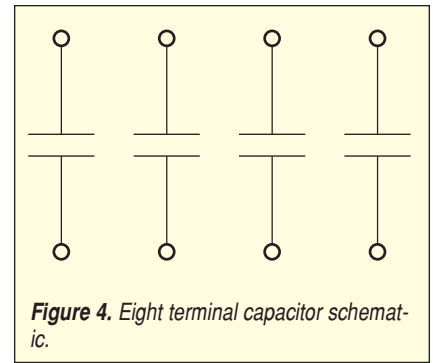
Figure 4. Eight terminal capacitor schematic.

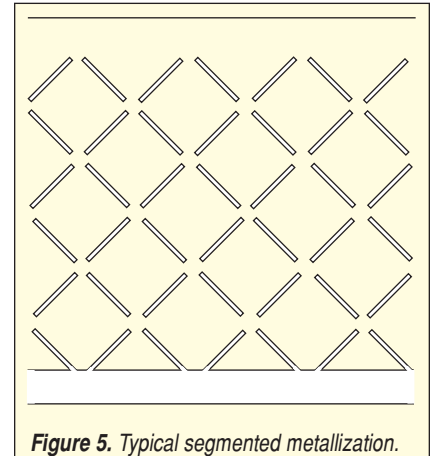
Figure 5. Typical segmented metallization.

In this 3.3kVdc capacitor, metallization consists of individual segments connected by narrow current gates (*Figure 5*). If one of the segments breaks down, the gates serve as fuses. Therefore, the damage to the capacitor is localized and the capacitance decreases only slightly while protecting the capacitor against complete destruction^[11]. *Figure 6* shows two gates of a segmented electrode that were closed by the energy from a selfhealing event.

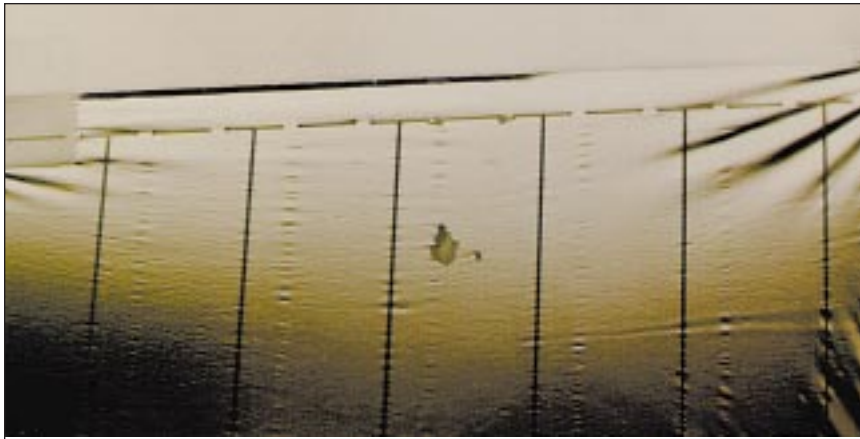
Figure 6. Operation of segmented electrode. (a). Dielectric puncture is in foreground (b). Two closed segmented fuses above.

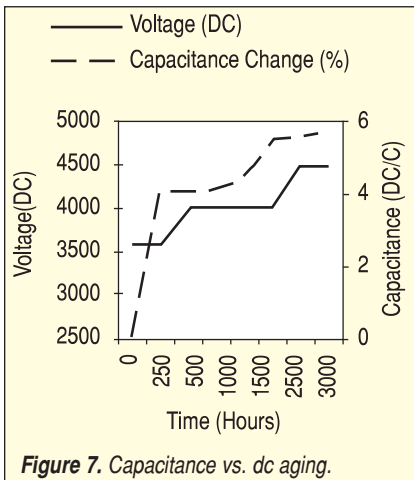
Figure 7. Capacitance vs. dc aging.

It was determined that only the capacitance value increased over the 3000hour period, as shown in *Figure 7*. This capacitance increase occurred at the start of testing due to electrostatic compression of the capacitor layers^[3]. This corresponds to a decrease in the gaps between adjacent electrodes in the wound capacitor elements that would normally increase the capacitance. What was of interest is not only did it occur at the start of testing, yet additional increases occurred after the voltage was stepped up further from 3.5kV to 4.0kV and again as the voltage was stepped from 4.0kV to 4.5kV after 2000 hours of testing. The dissipation factor during the testing was also monitored and although it went up about 20% during intermediate test intervals, it had dropped to its original value at the end of 3000 hours. Therefore little aging was observed after 3000 hours at substantially accelerated conditions on the 3.3kV design, including the final 1000 hours testing at 36% over nominal voltage.

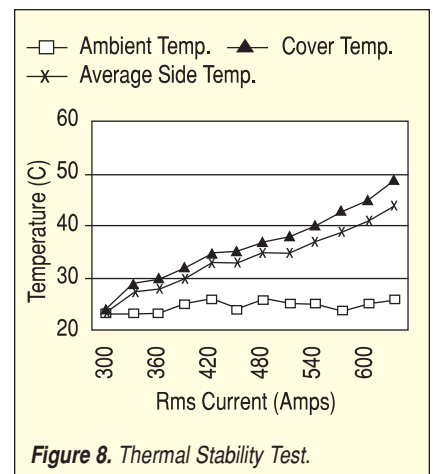
Figure 8. Thermal Stability Test.

Voltage in the resonant circuit was increased in steps and the capacitor ripple voltage at 10kHz was monitored on an oscilloscope. The current was obtained by Ohm's Law. The ambient temperature was monitored in the test area in addition to the temperature on the capacitor's cover and on both sides. The current on the capacitor was increased stepwise in 30A steps starting at 300 until a reasonable maximum current rating of 600Arms was obtained. At the lower steps the dwell time was 9 hours per step with the capacitor at rest at night. At the 600Arms step the capacitor was run continuously for 48 hours to determine its thermal stability.

The current steps and their temperature measurements for the thermal stability test are in *Figure 8*. After the completion of the 600A step, the ripple current was increased to 630A for an additional nine hours and the temperature measurements were

It was desirable that the hot spot be below 80°C with a 5°C safety margin. At 25° ambient and 600Arms, the highest temperature was 45°C on the capacitor cover near the terminals. The cover would normally be expected to have a higher temperature because that is where the inner connections carry the heat. At 630Arms it can be seen that the selfheating has started to accelerate.

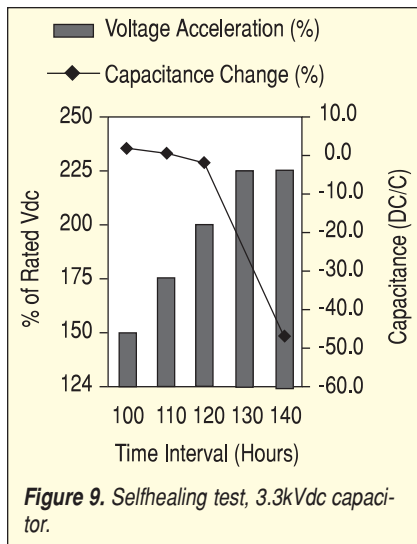
The accelerated aging evaluation clearly demonstrated capabilities up to 136% of rated voltage at 85°C. The test of the selfprotection feature was therefore started at 150% of rated voltage and stepped in increments of 25% of rated voltage. During this testing, pressure switches designed to open at 10 \pm 1 psi were installed in the capacitors in series with the voltage source. The step at 150% of rated voltage was for 100 hours and subsequent steps at 175% and 200% of the rated voltage were for 10 hours per step. The final step at 225% of the rated voltage was run until the capacitances were reduced to approximately 50% of their original measured values. The capacitance variation during this test is shown in *Figure 9*.

The selfprotection feature of the design was clearly demonstrated, although some capacitance reduction was observed at 175% of the rated voltage, substantial degradation did not start until 200% of the rated voltage. The capacitance loss accelerated

at 225% of the rated voltage. After eight hours at this step, the loss was about 25% on all samples. At 12 hours it was close to 40%, and at 16 hours it was close to a 50% reduction. After the 50% reduction in capacitance a bulge of 0.25 cm was detected in the sides of both samples, although this was not enough to activate either pressure switch.
